Affordable Drive Train Housings Manufacturing Technology Objective Magnesium Corrosion Protection Program (MCP) Implementation

PROBLEM / OBJECTIVE

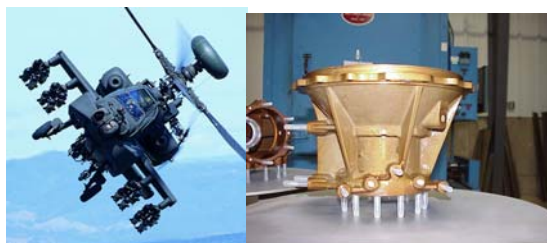
A holistic approach was taken starting with the development of a process to remove the existing surface finish and corrosion, followed by surface activation and the selection and application of organic coatings. All evaluations were performed on ZE41A-T5 magnesium alloy.
